FOREST PRODUCTS RESEARCH IN PICTURES

**TREATING-PLANT PLANK PREACHES
SERMON ON WOOD ROT**

**FOREST PRODUCTS LABORATORY
U. S. FOREST SERVICE
MADISON, WISCONSIN**

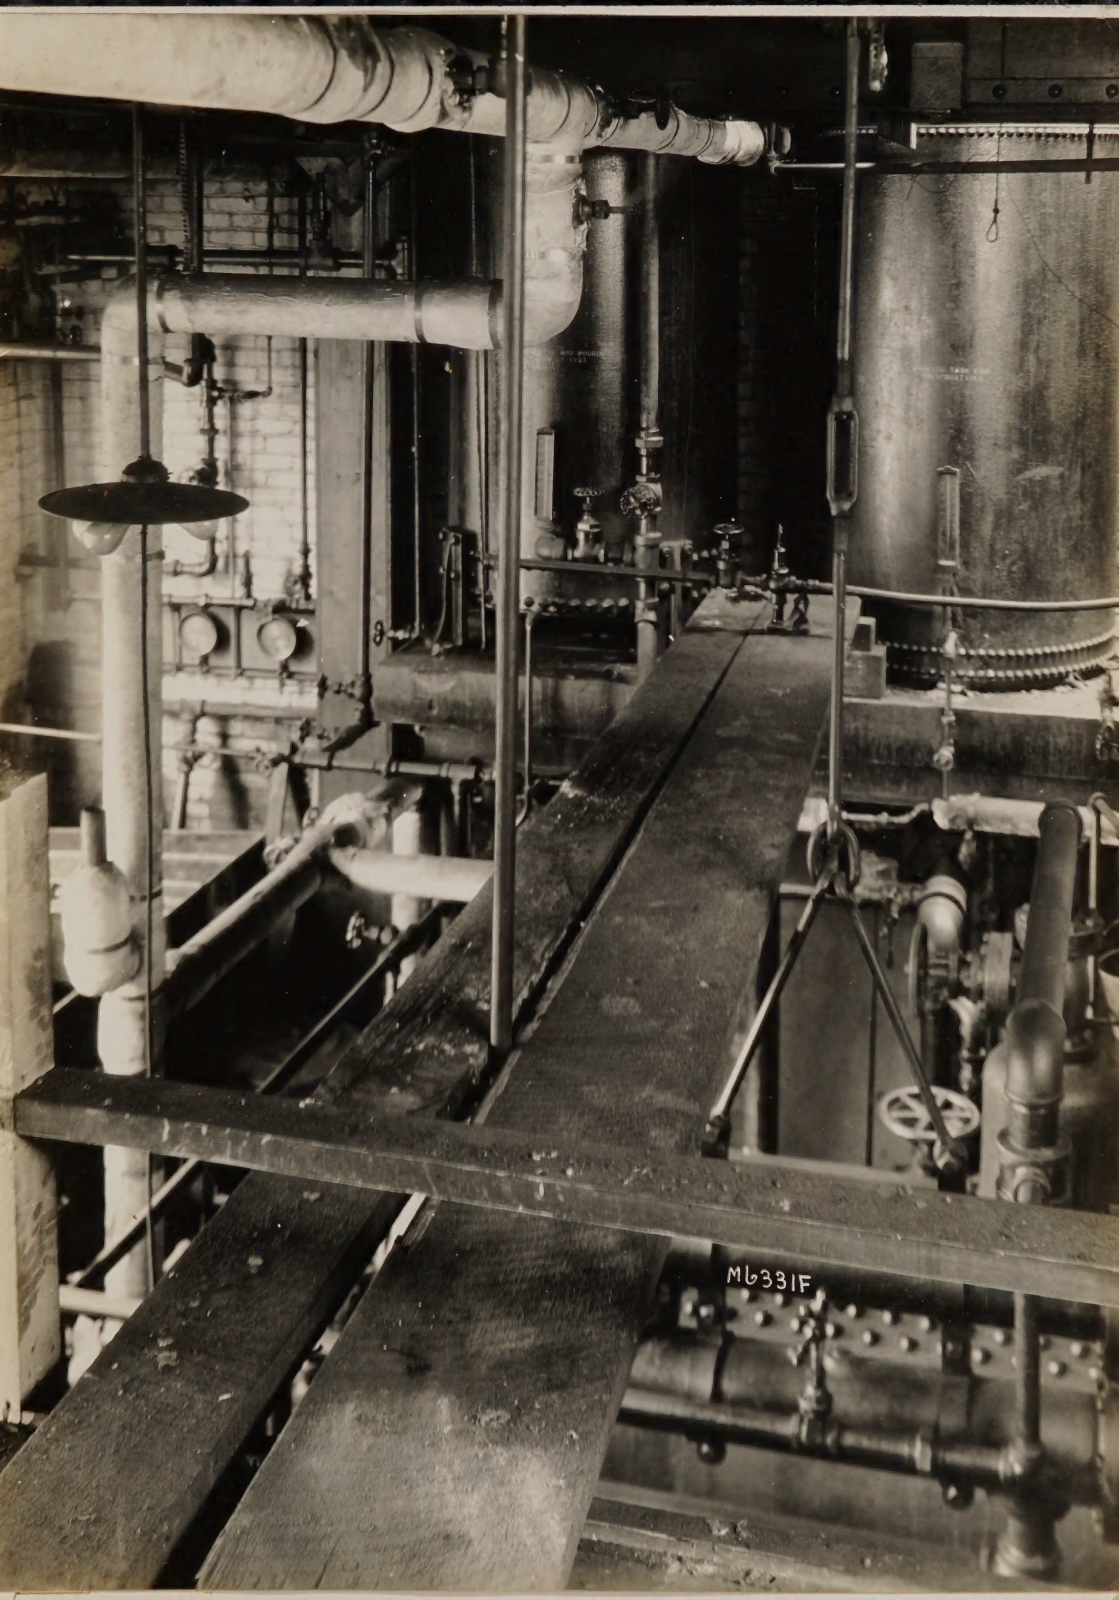
NO. 76

This picture shows a walkway as it formerly extended over the treating cylinder in the wood preservation section of the U. S. Forest Products Laboratory. In spite of its elevated location and the rising fumes of hot creosote and other preservative chemicals that frequently bathed it, two badly rotted spots were recently found in the plank shown at the left. The decay spots are directly traceable to drip from two steam valves overhead. Under the peculiar conditions described, the presence of decay forcefully illustrates the fact that when moisture collects in wood decay is an ever-present hazard. Immunity for wood in ordinary service can be had by keeping it dry or by effectively treating it with preservatives.
